A rocking electric winch motor

Visualization of vibrations through advanced measurements and FEM calculations

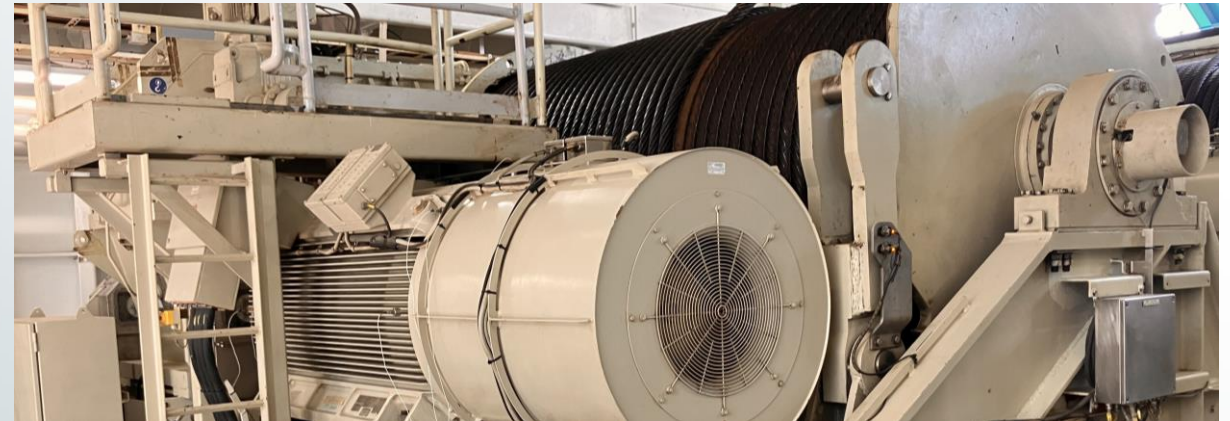
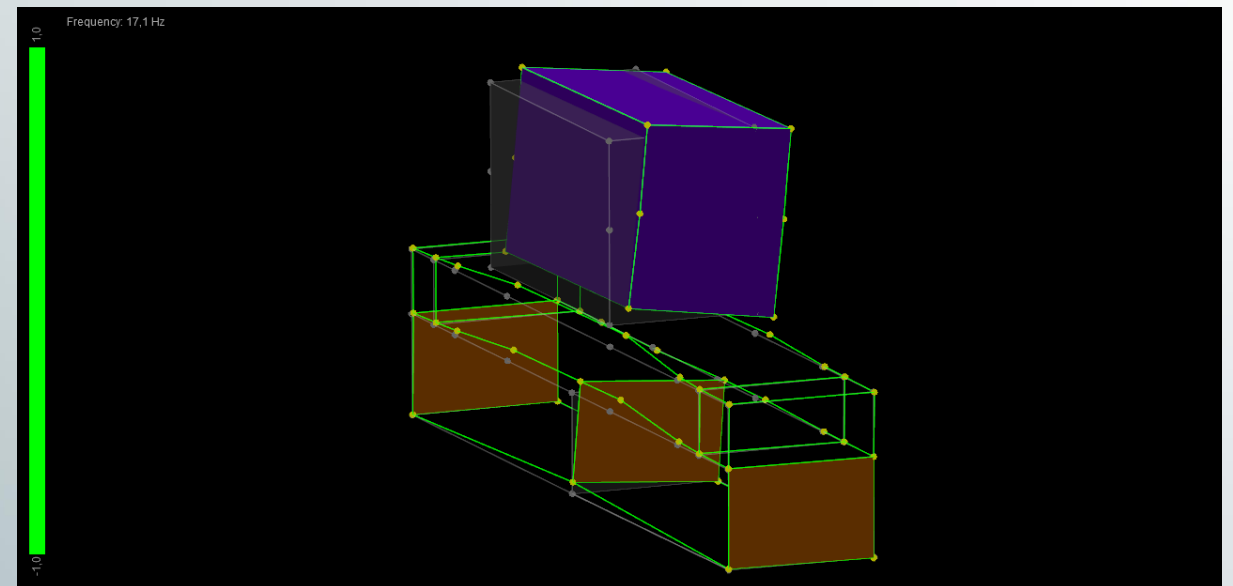
Operating Deflection Shape animation showing dominant rocking mode shape externally excited by the Inboard Dredge Pump.

The measurements confirmed a local structural resonance at 17.0Hz with a so-called rocking mode, being excited by the Blade Pass Frequency in the operational range of the dredge pumps. The ~20% higher mass of the upgraded e-motor had lowered the natural frequency. The modal analysis was compared and calibrated to the measurements to achieve a reliable basis for simulating effective improvements. This resulted in targeted reinforcements and a new natural frequency of 22.8Hz being sufficiently away from the normal excitation range. Subsequent validation measurements showed levels within common limits.

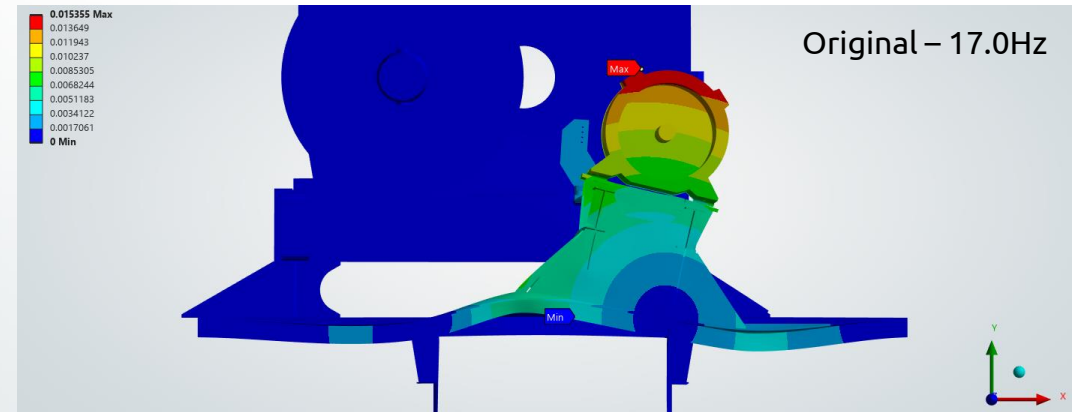
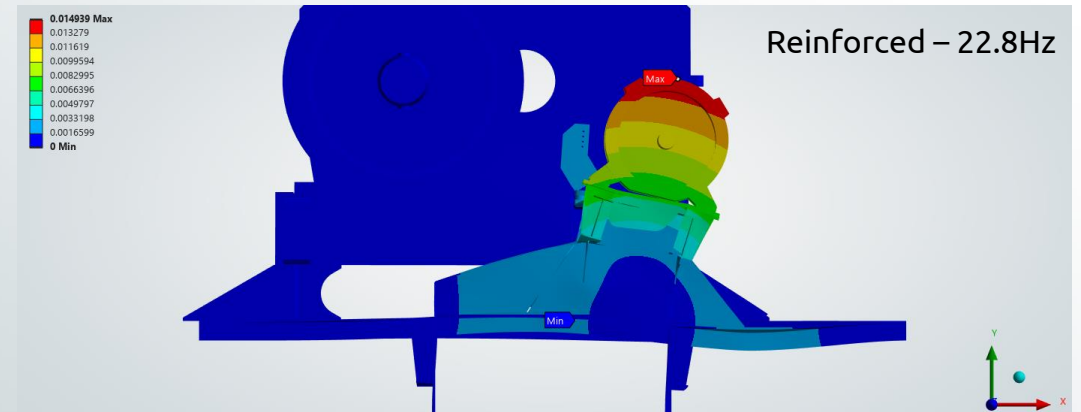
FEM calculations as calibrated on the measurements, with improvements.

Specialised expertise: The powerful combination of measuring and calculations resulted in an actionable solution with production drawings for the base frame stiffening.
