# Abnormal noise from a winch gearbox

Diagnosed through a vibration measurement and visual inspection

# Case – Abnormal noise from a winch gearbox

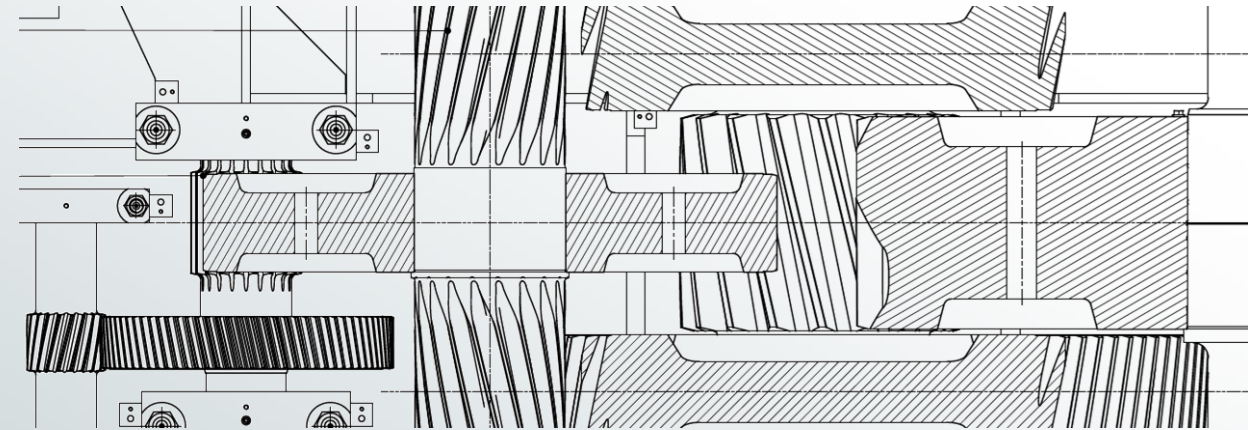
General arrangement of the gear internals.

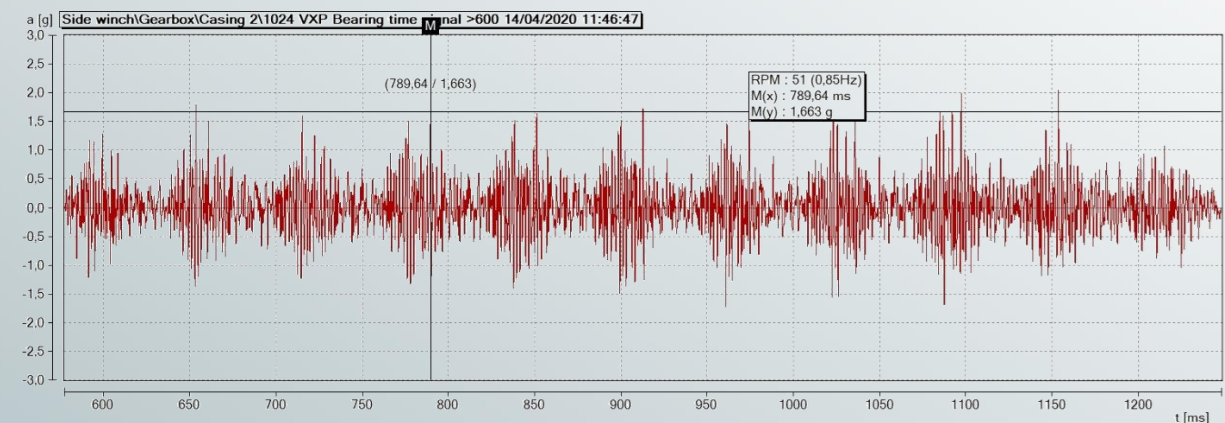
Due to its large size with many gears and 5 shafts, a visual inspection turned out not so easy. Therefore, the MDS engineer started with a vibration measurement by means of a portable spectrum analyzer. Because the overall vibration levels appeared very low, advanced time waveform analysis was used. This can be very effective for diagnosing gearbox faults as opposed to frequency spectrum analysis alone. The number of the detected impacts indicated an issue with the 3<sup>rd</sup> gear stage, and further narrowed down, the amplitude modulation particularly pointed towards the pinion shaft.

Time waveform showing the distinctive impacts related to the abnormal sound.

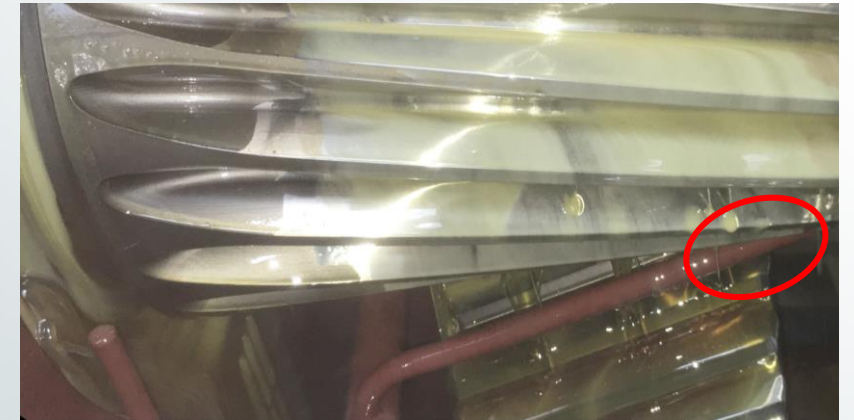
During the subsequent inspection, this focal point derived from the vibration analysis in combination with a practiced eye, quickly resulted in finding the root cause. Although hard to see through the inspection hatches, it was observed that one of the lubrication oil spray pipes was touching the teeth of the suspected pinion shaft. The reason for such a rather rare symptom not being detected in the factory is that due its enormous size and a weight of 103t, the gearbox had to be transported into parts. As such, the issue with a misaligned oil spray pipe was deemed to be introduced during the reassembly.

*Visual inspection revealed the oil spray pipe in touch with the pinion teeth.*

Root cause resolved: All stakeholders and most importantly the client were relieved and reassured to continue the commissioning after fixing the issue. Because after all, the issue appeared not as detrimental as the sound suggested.
