# Reduced propulsion engine power

Solved by a shaft power measurement and teamwork troubleshooting efforts

# Case – Reduced propulsion engine power

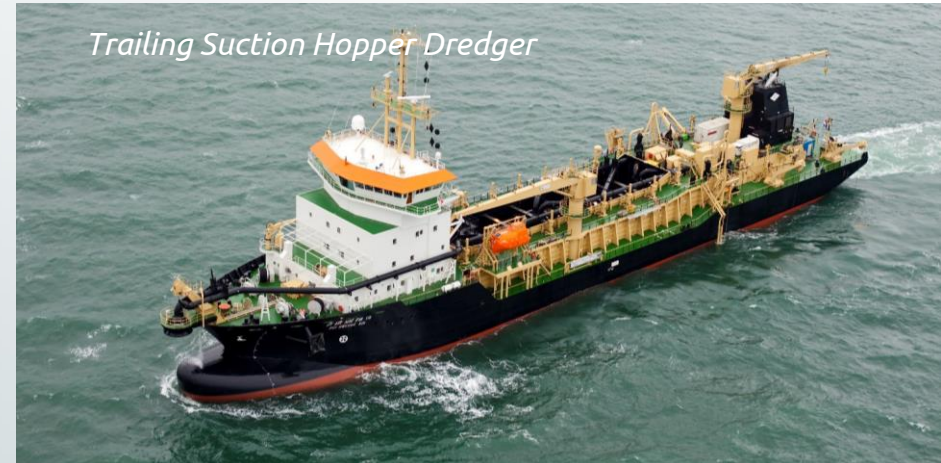
Strain gauges and special telemetry equipment were installed on both propulsion shafts. Accurate power measurements were taken in such a way that all parties including the client could real-time monitor the actual output. Similar measurements were also taken on copy vessels in the fleet for comparison.

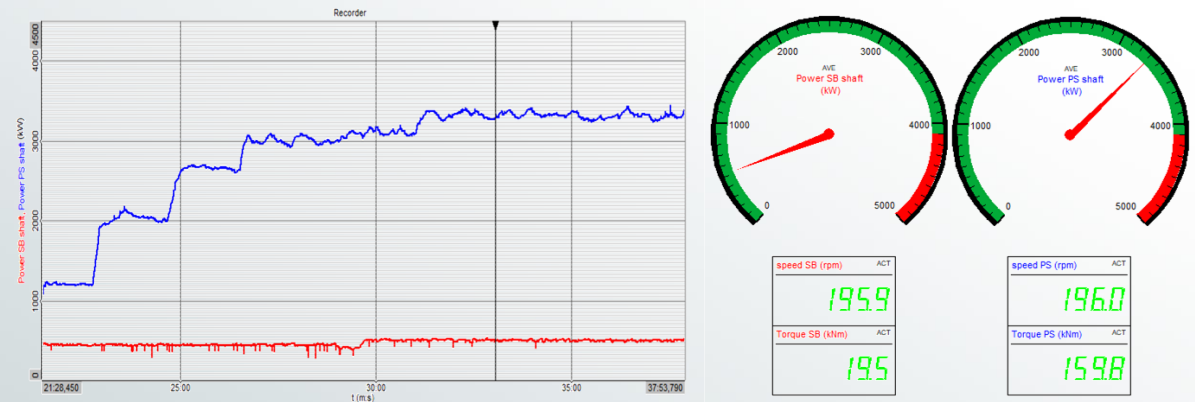
The power measurements confirmed indeed an actual main diesel engine output of only ~3.300kW instead of the nominal 4.100kW. However, no damage indications were found on the diesel engines and all control settings were correct. Furthermore, the sister vessels were performing better and did meet the specifications. During subsequent technical discussions, the fault tree was narrowed down to fuel, and it was confirmed by the customer that the vessel was refueled by another supplier.

Measurement data showing the maximum power on the PS propulsion shaft

Finally, the fuel was analyzed in a laboratory in close cooperation with the engine supplier. The results undeniably showed that the quality of the fuel was far below the requirements, causing serious power losses.

Root cause resolved: inferior fuel quality was identified the root cause of lower main diesel engine output power, ruling out other technical issues.
